**DOT/FAA/AR-96/21**

# **Composite Failure Analysis Handbook Update 1**

**WL-TR-93-4004**

August 1997

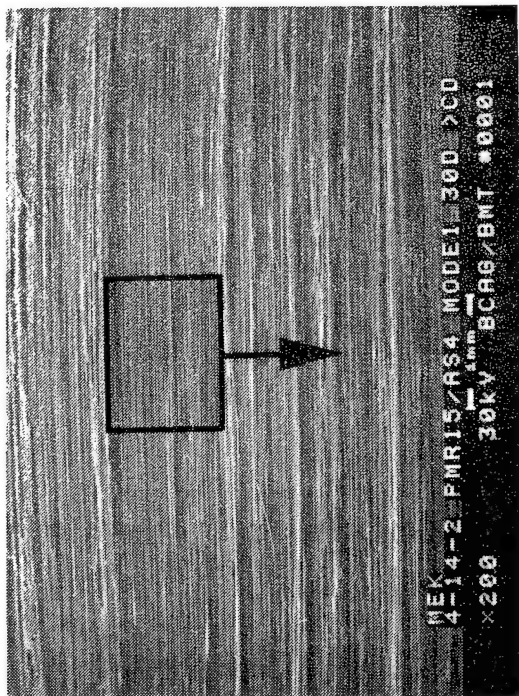
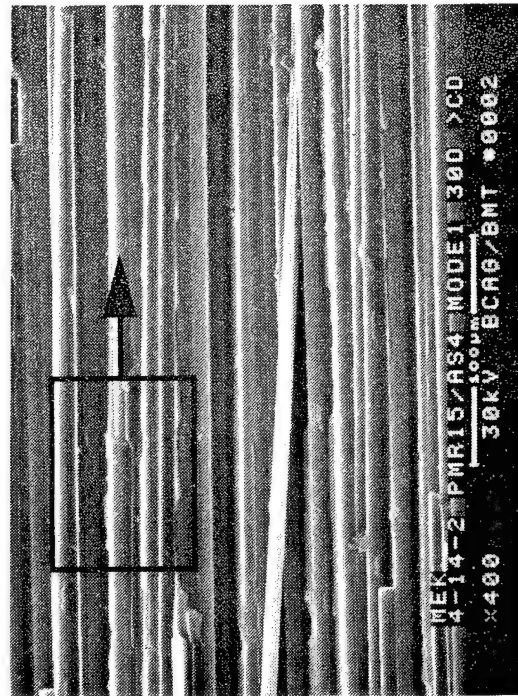
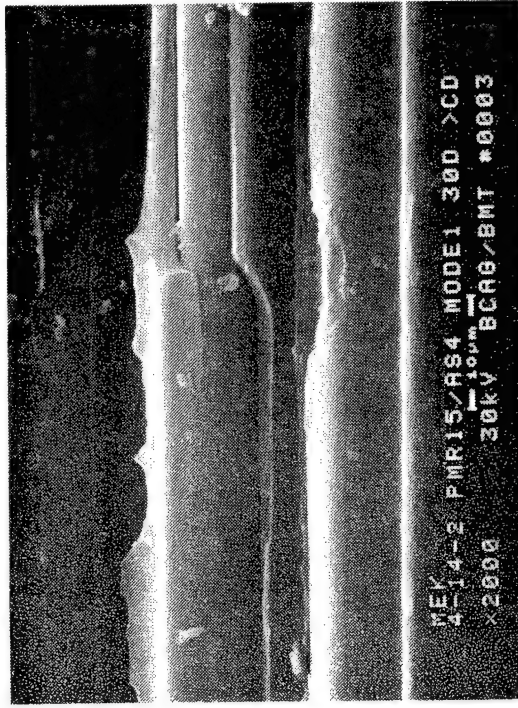
The effects of the exposure did not affect the fracture morphology to any noticeable degree. All of the characteristic mode I surface features were easily identified (Figure 3.3-9 through 3.3-15).

Figure 3.3-11. SEM Fractographs of a PMR-15/AS4 Interlaminar Mode I Tension Fracture Surface Exposed to MEK for 24 hours

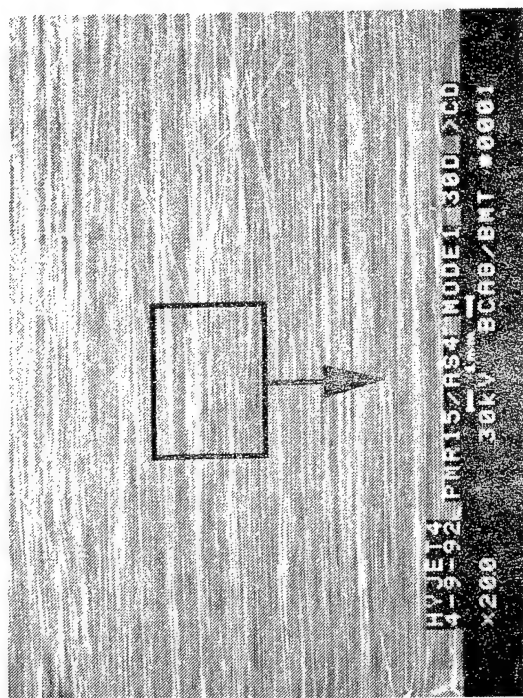
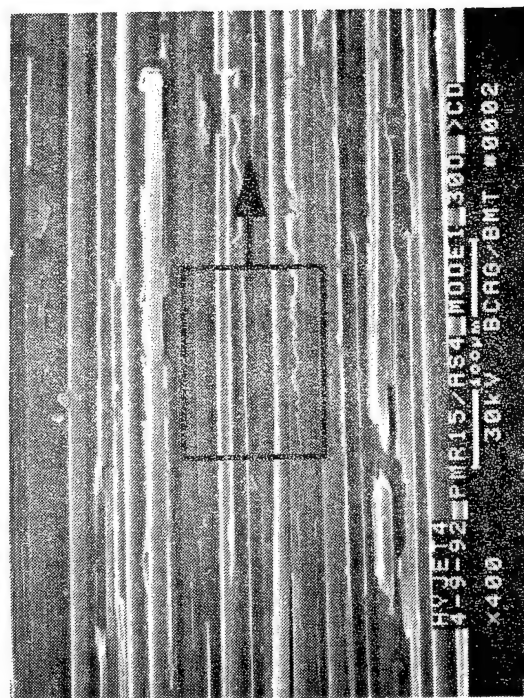
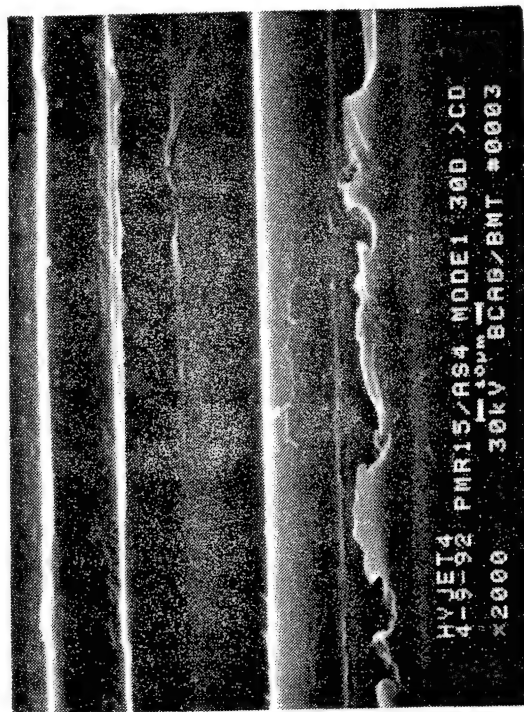
Figure 3.3-12. SEM Fractographs of a PMR-15/AS4 Interlaminar Mode I Tension Fracture Surface Exposed to Hydraulic Fluid for 7 Days

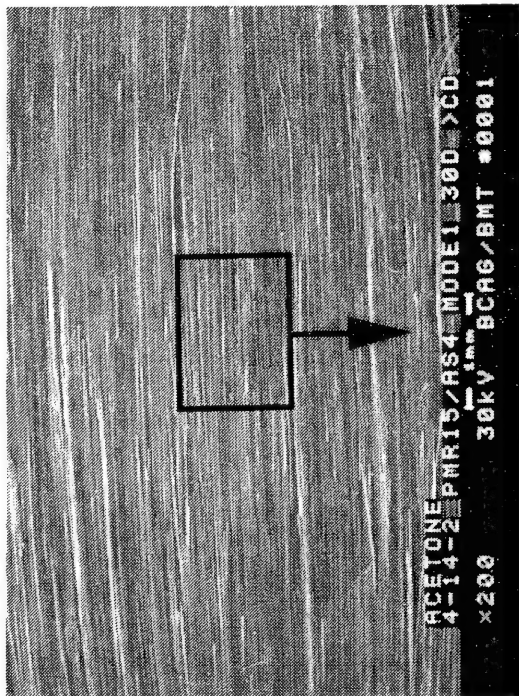
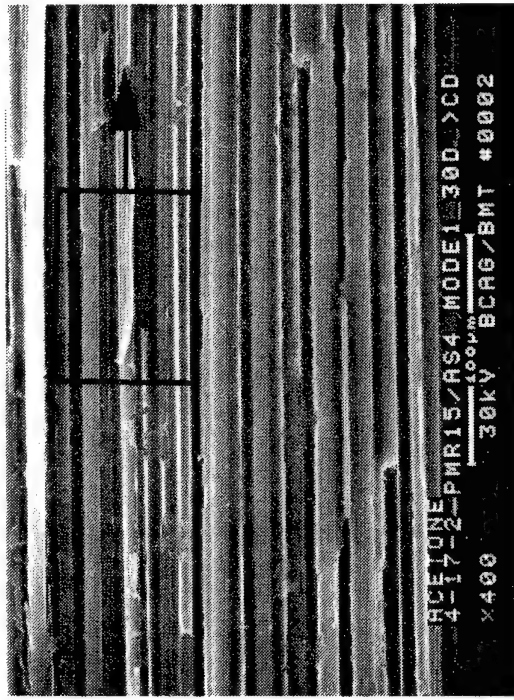
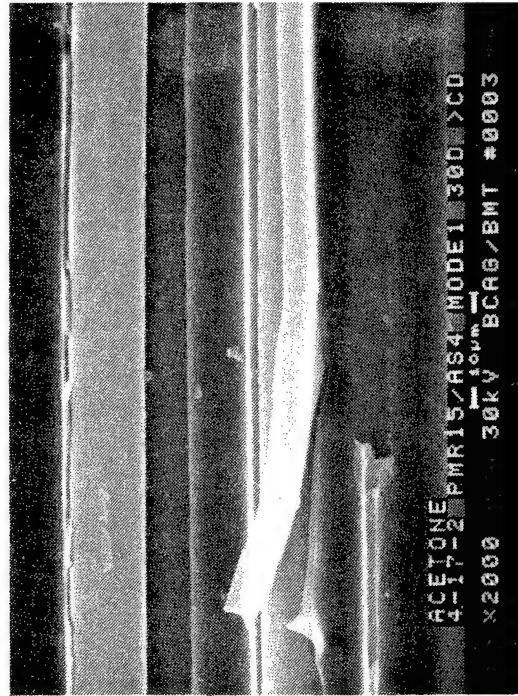
Figure 3.3-13. SEM Fractographs of a PMR-15/AS4 Interlaminar Mode I Tension Fracture Surface Exposed to Acetone for 24 hours

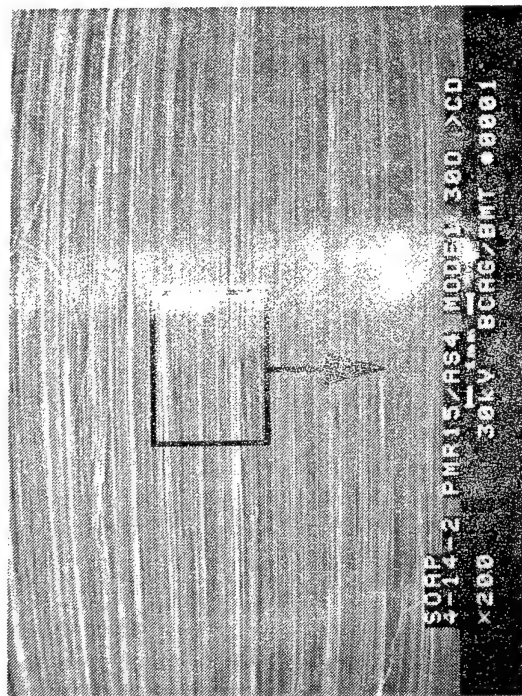
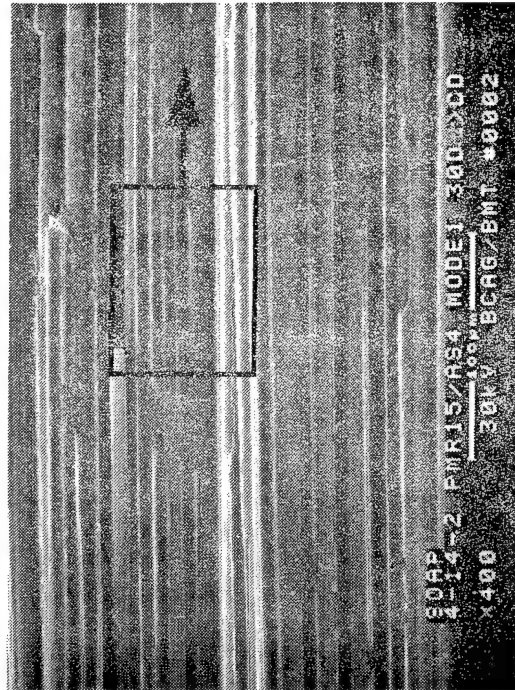
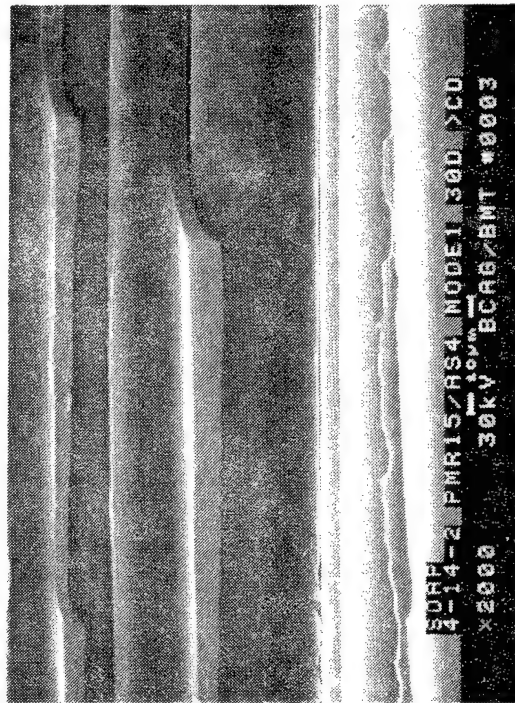
Figure 3.3-14. SEM Fractographs of a PMR-15/AS4 Interlaminar Mode I Tension Fracture Surface Exposed to Soap Solution for 24 hours

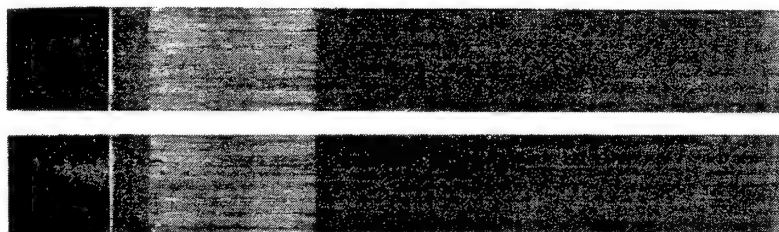
Figure 3.4-7. Optical Fractographs of a APC-2/AS4 Interlaminar Mode I (Tensile) Fatigue Fracture Surface, 250° F

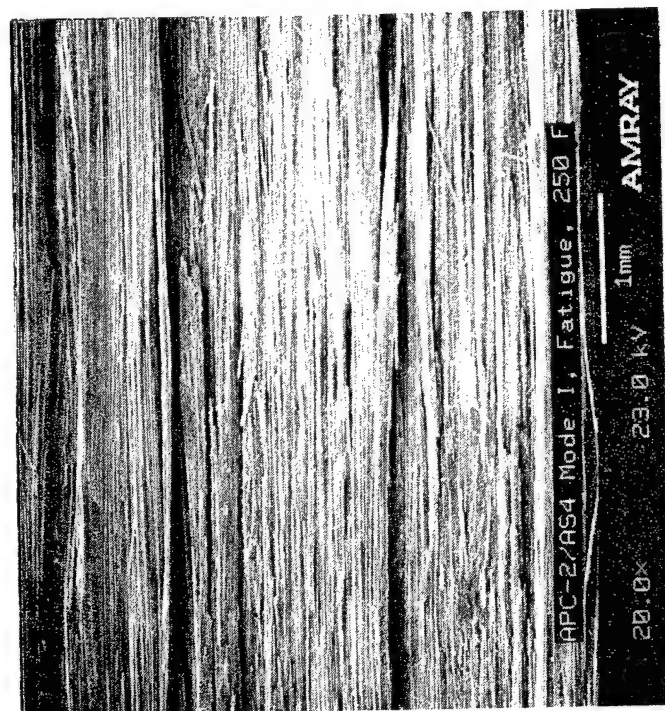
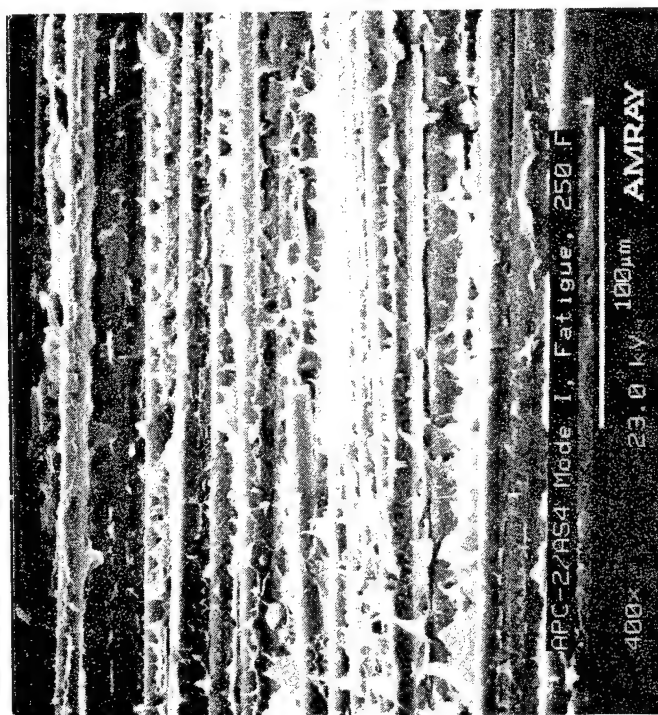
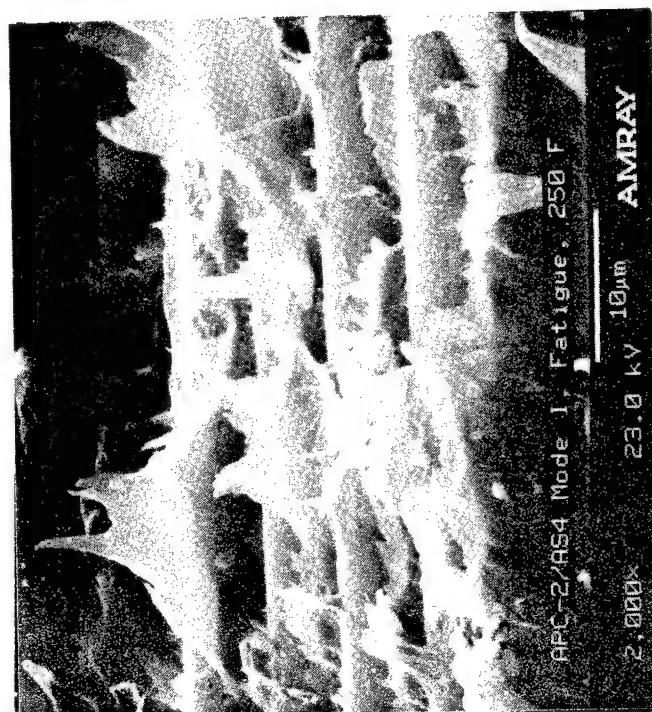
Figure 3.4-8. SEM Fractographs of a APC-2/AS4 Interlaminar Mode I (Tensile) Fatigue Fracture Surface, 250° F

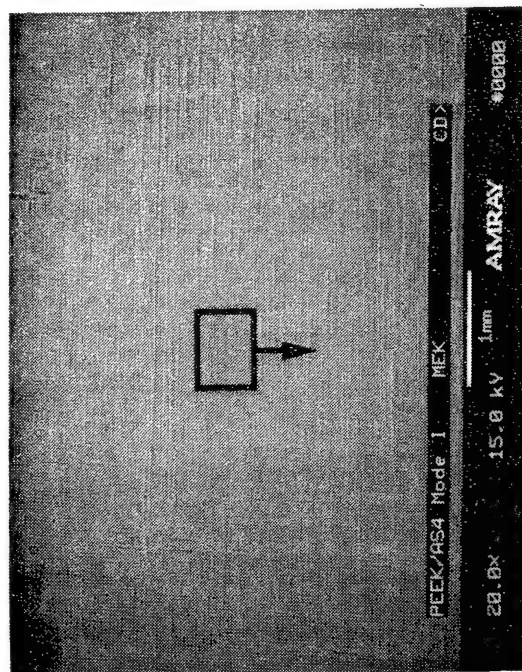
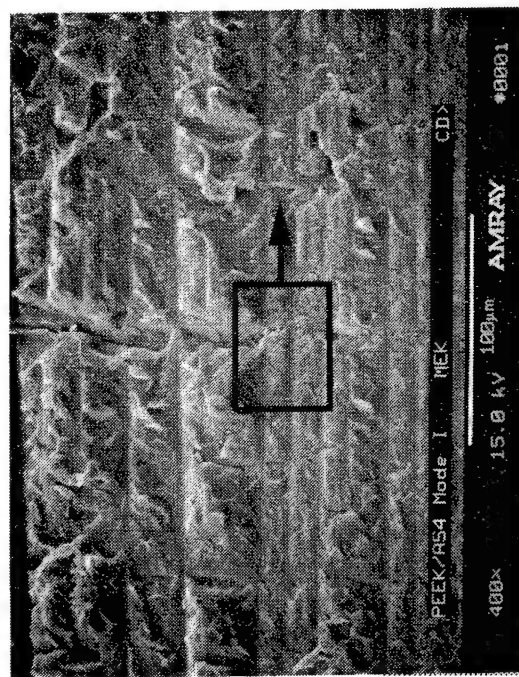
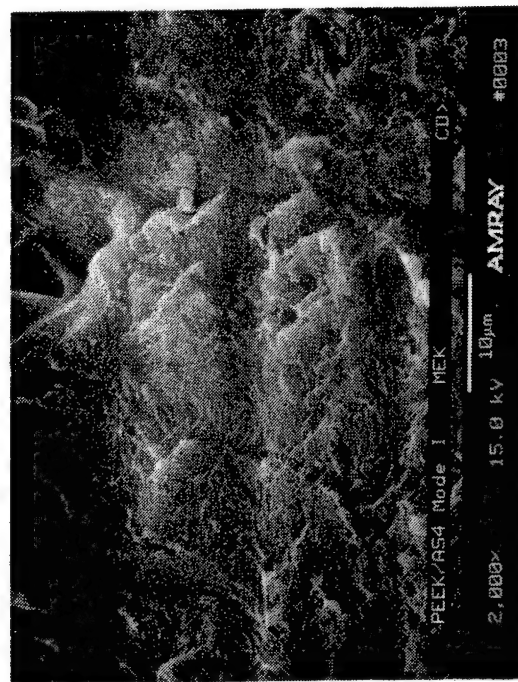
Figure 3.4-9. SEM Fractographs of a PEEK/AS4 Interlaminar Mode I Tension Fracture Surface Exposed to MEK for 24 Hours

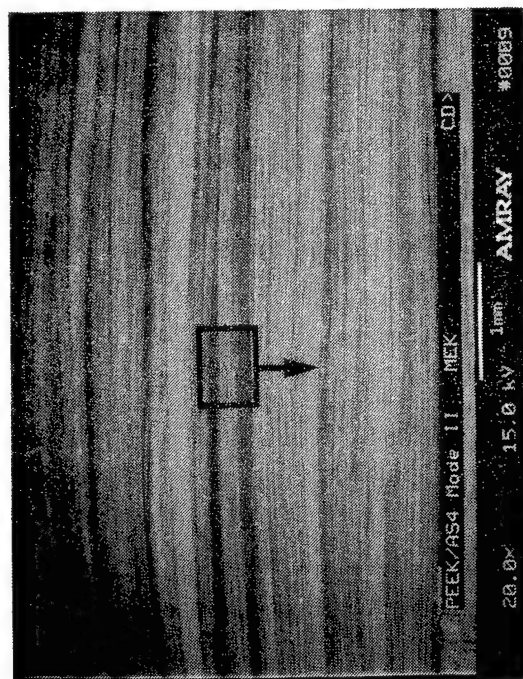
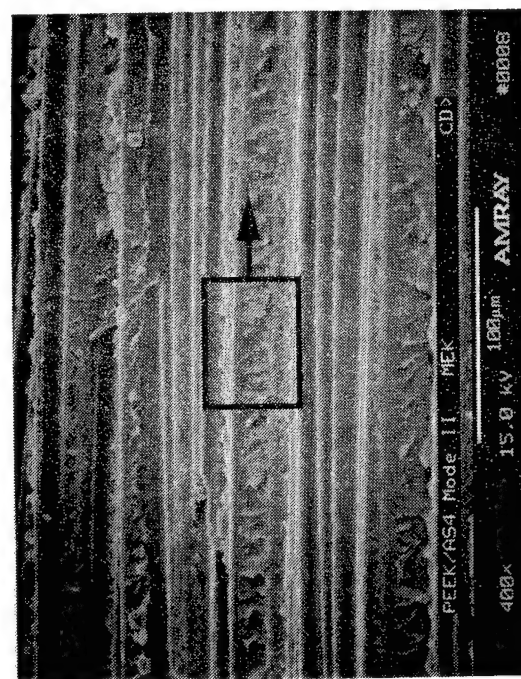
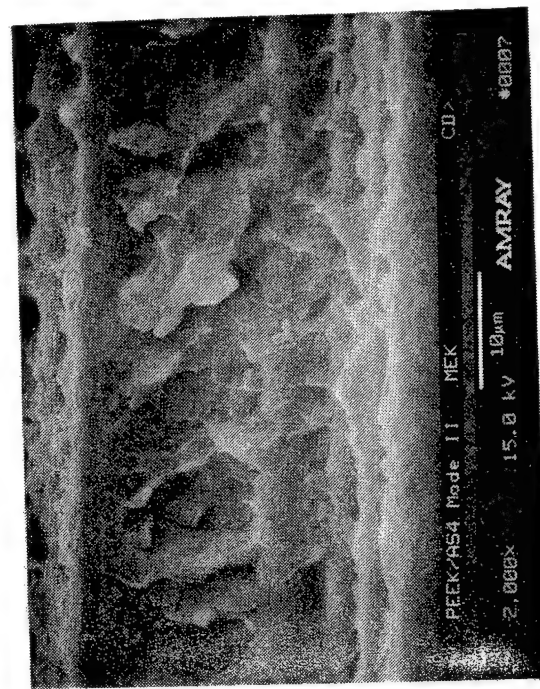
Figure 3.4-10. SEM Fractographs of a PEEK/AS4 Interlaminar Mode II Shear Fracture Surface Exposed to MEK for 24 Hours

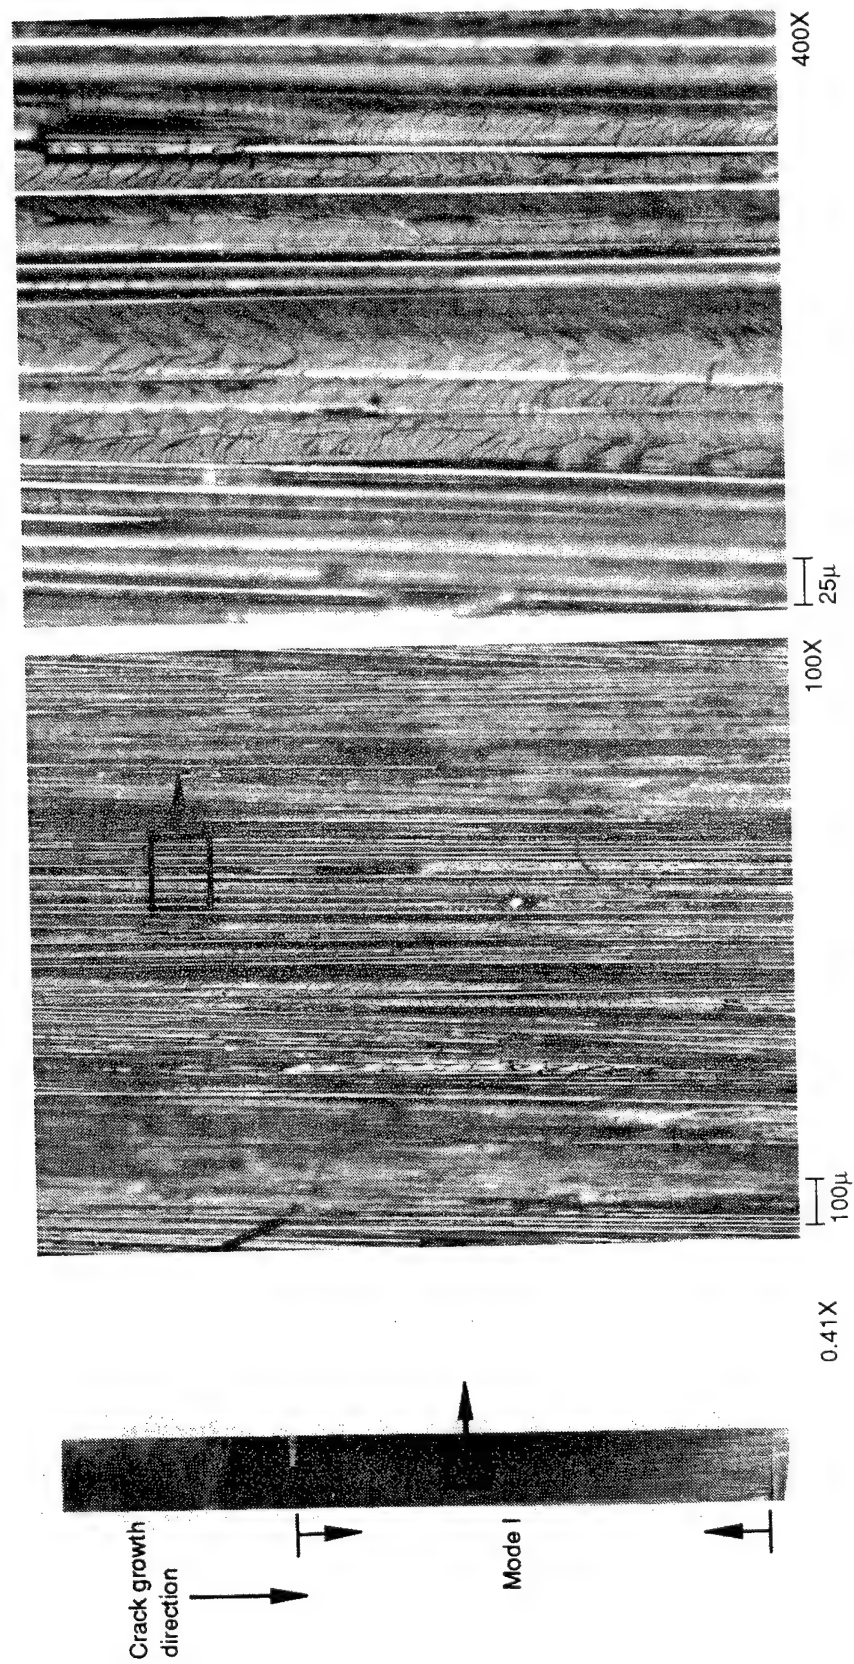
Visual observation revealed a smooth, glassy surface typical of an interlaminar mode I tension fracture. However, fragments of loose fibers were apparent on the fracture surface. These fibers were separated from the matrix (possibly due to weak fiber/matrix adhesion). Under the optical microscope, fine rivermarks were observed, indicating the overall crack propagation direction (Figure 3.5-1). As shown in Figure 3.5-2, SEM examination revealed rivermarks between the carbon fibers. These rivermarks indicated the crack growth is consistent with the mechanically induced crack direction.

Figure 3.5-1. Optical Fractographs of BM/AS4 Interlaminar Mode I Tension Specimen Tested at RT/Dry

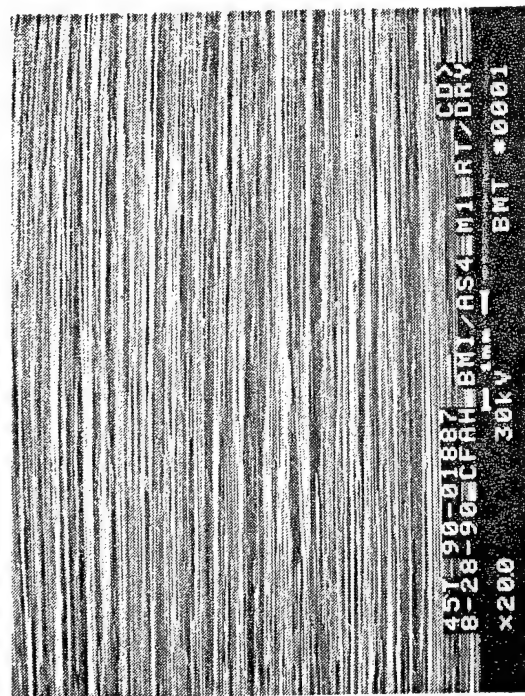
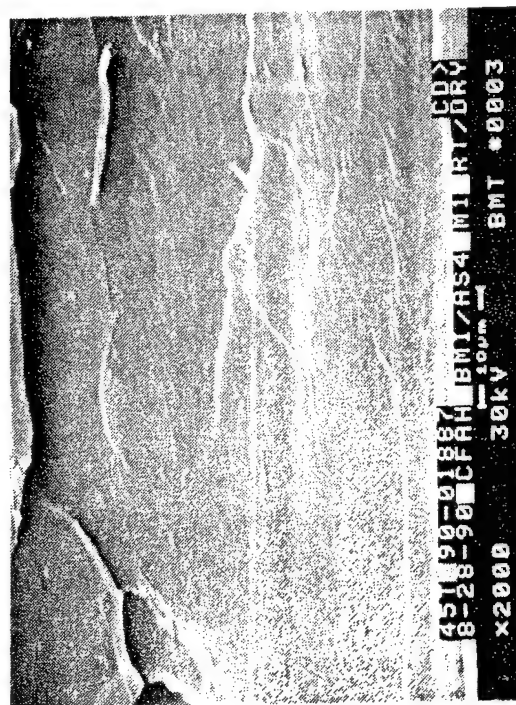
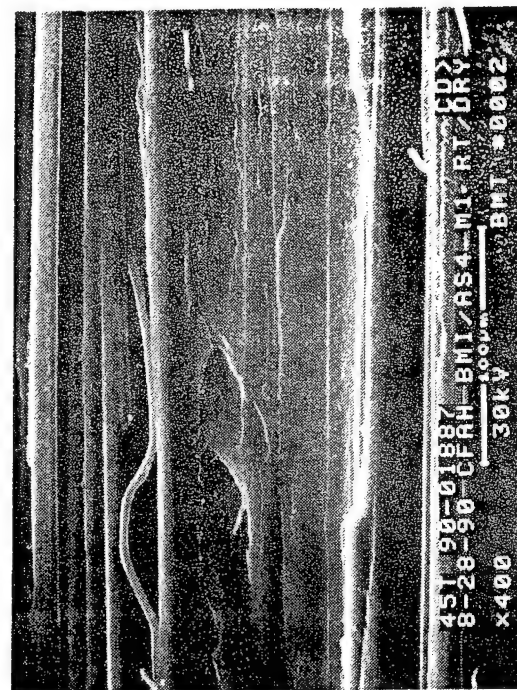
Figure 3.5-2. SEM Fractographs of an AS4/EMI Interlaminar Mode I Tension Specimen Tested at RT/Dry

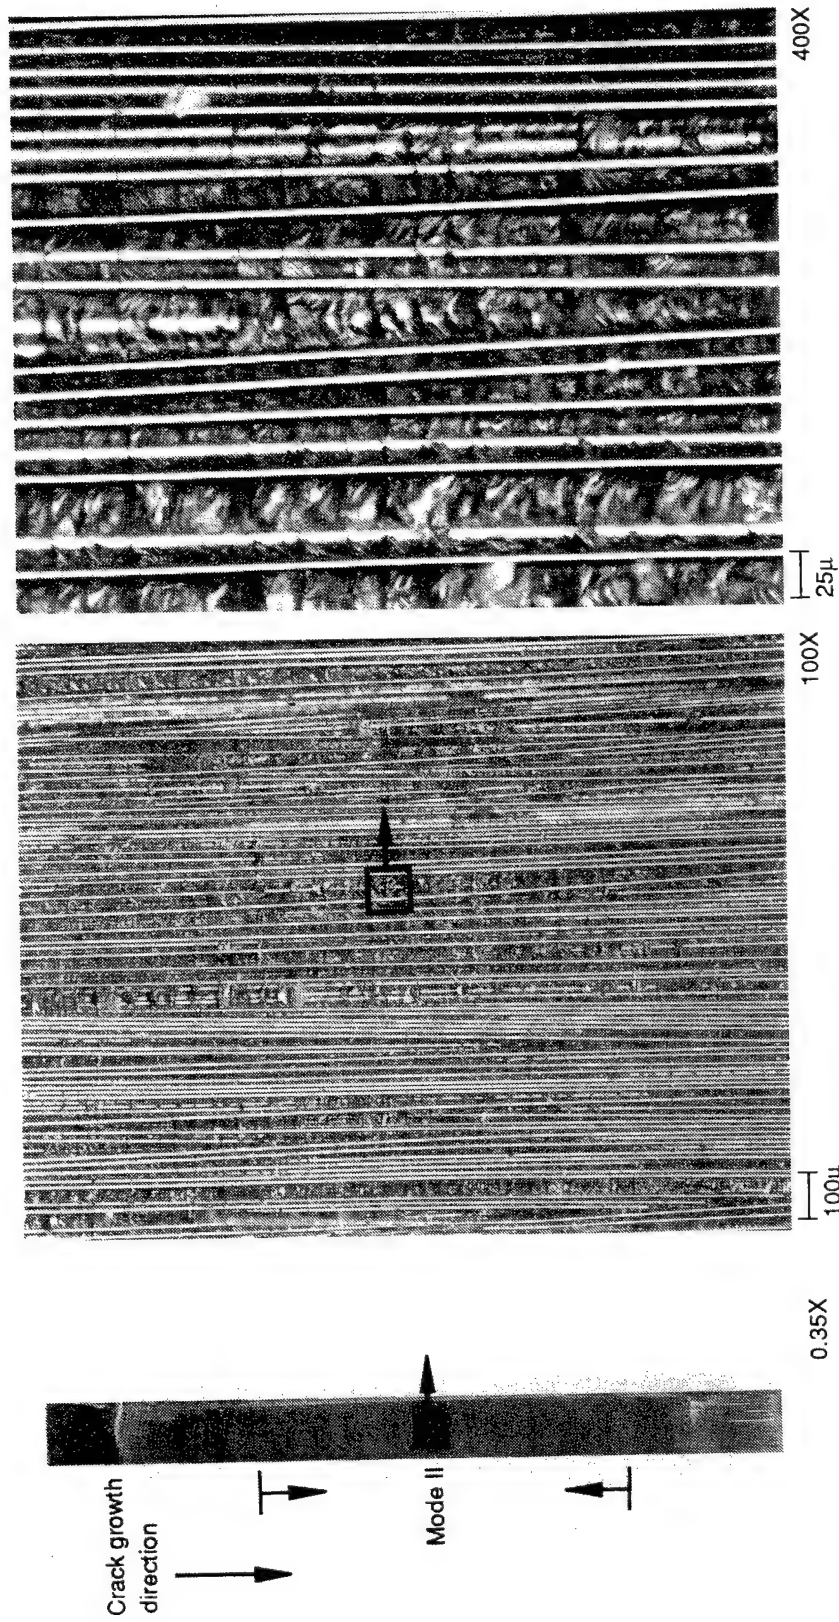
Visual observation of the fracture surface revealed a flat but milky appearance when held at an angle to the light. The milky appearance is due to the hackle formation created by shear loading, which was observed at higher magnification under the optical microscope (Figure 3.5-3). SEM examination revealed hackles of different sizes, shapes, and tilt angles located between the carbon fibers (Figure 3.5-4).

Figure 3.5-3. Optical Fractographs of BMI/AS4 Interlaminar Mode II Shear Specimen Tested at RT/Dry

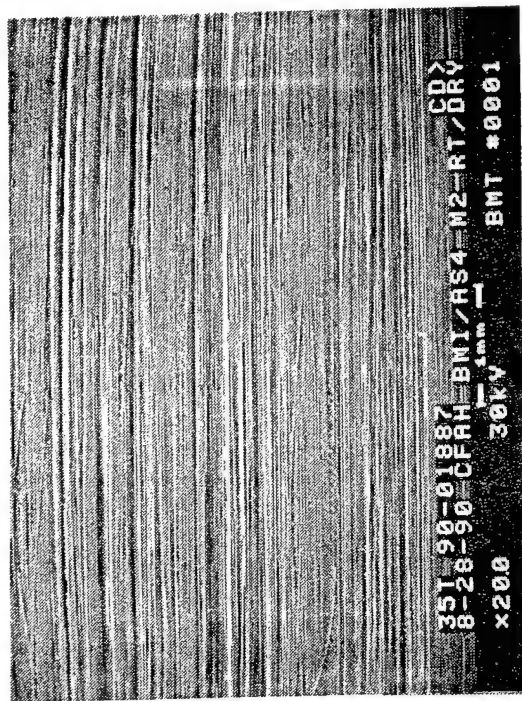
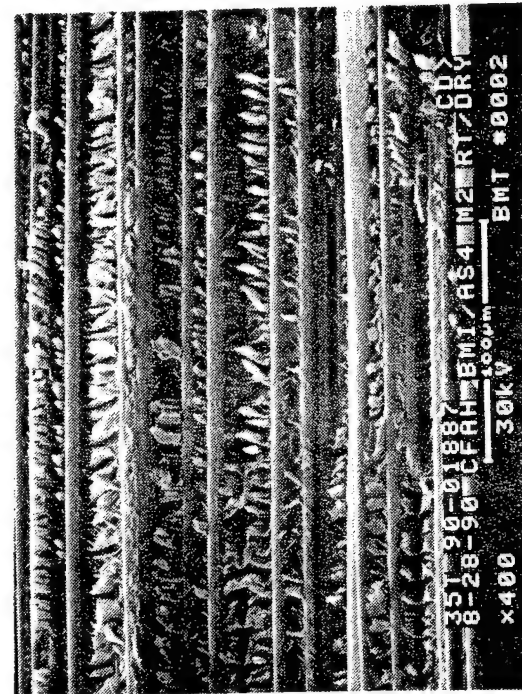
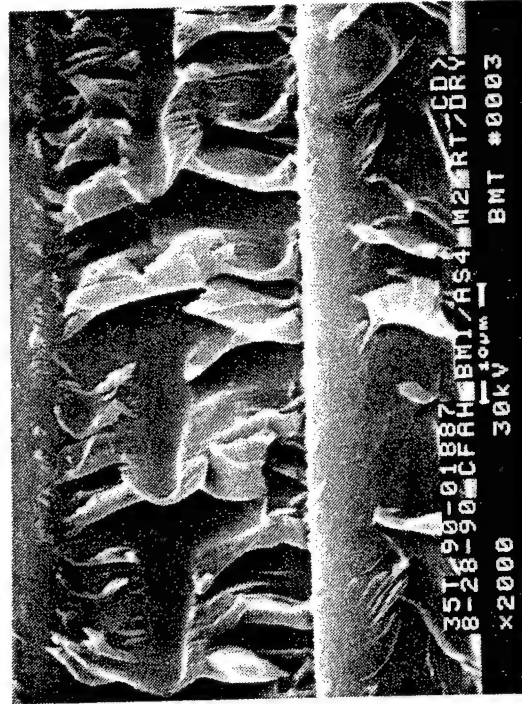
Figure 3.5-4. SEM Fractographs of an AS4/BMI Interlaminar Mode II Shear Specimen Tested at RT/Dry

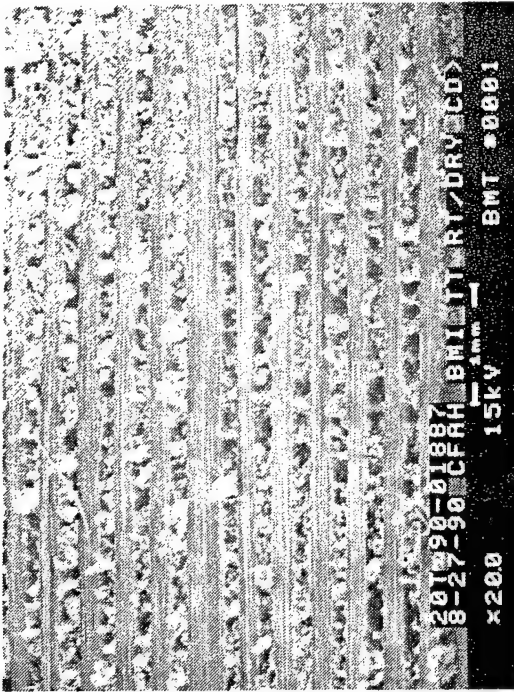
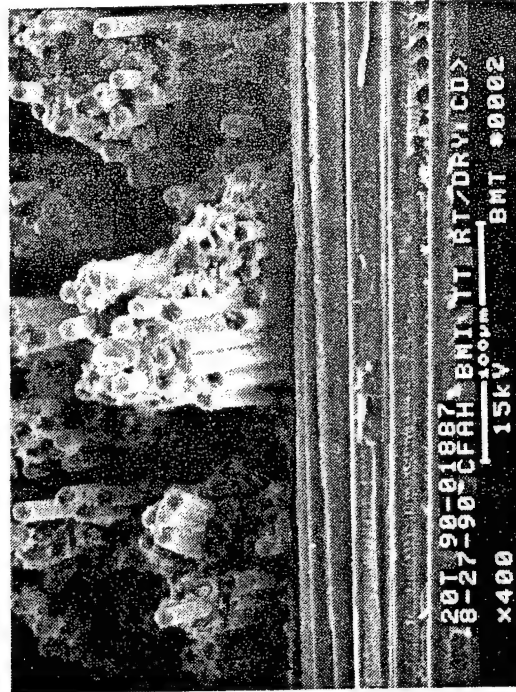
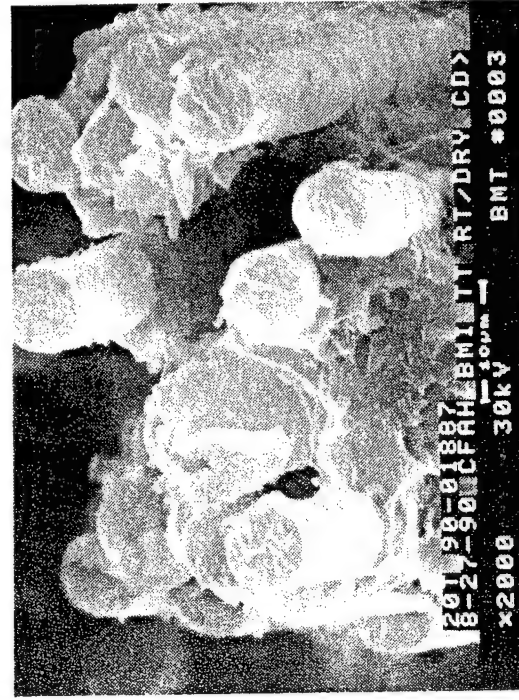
SEM fractography (Figure 3.5-5) revealed radial patterns on the fiber ends, indicating a resultant crack direction consistent with the mechanically induced direction. The specimen tested at 450° F did not fracture but only bent during the testing (Figure 3.5-6)

Figure 3.5-5. SEM Fractographs of an AS4/BMI Translaminar Tension RT/Dry Fracture

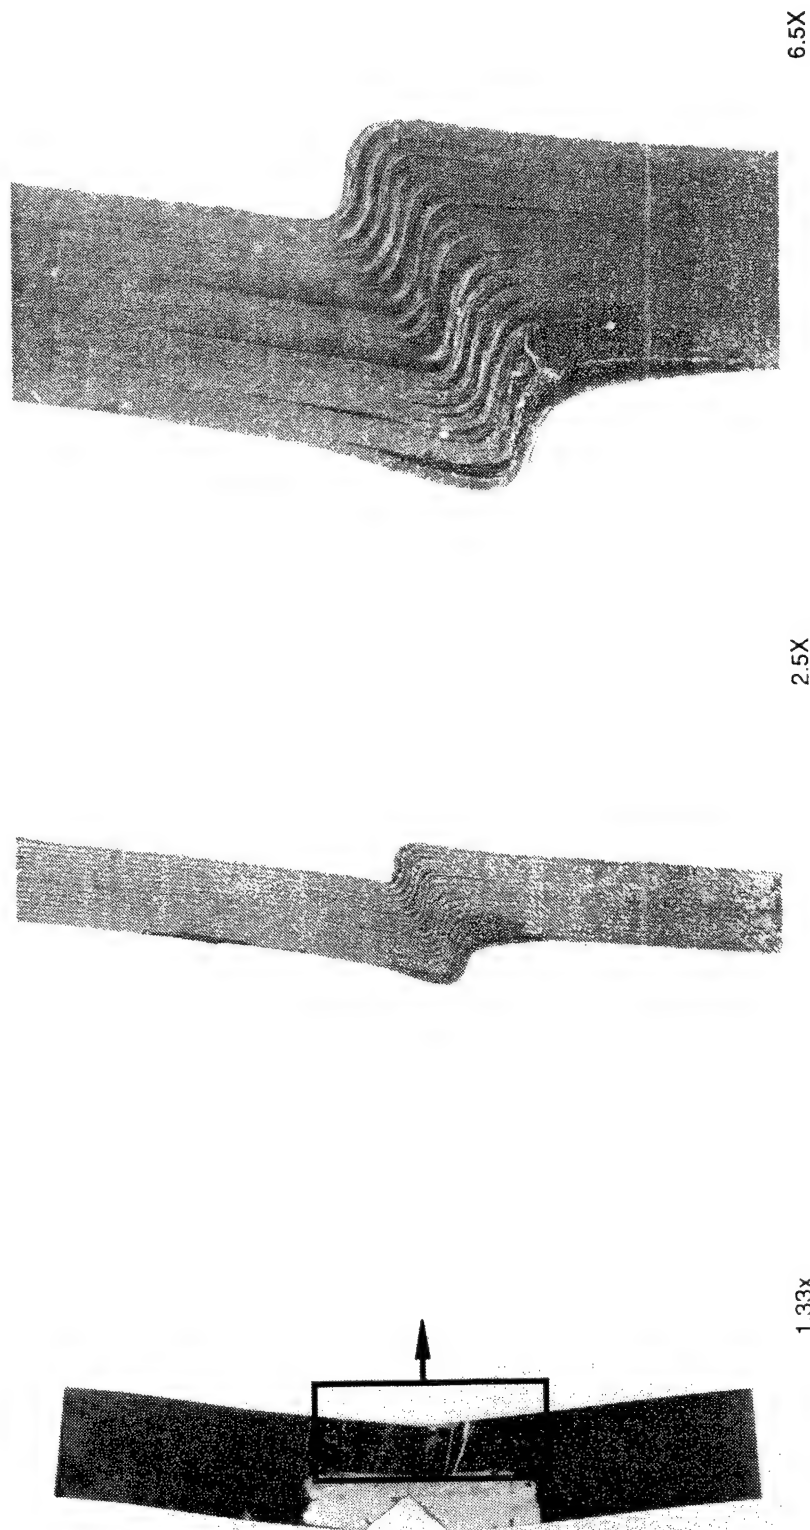
Figure 3.5-6. Macrophotographs of BMI/AS4 Translaminar Tension Specimen Tested at 450° F/Dry

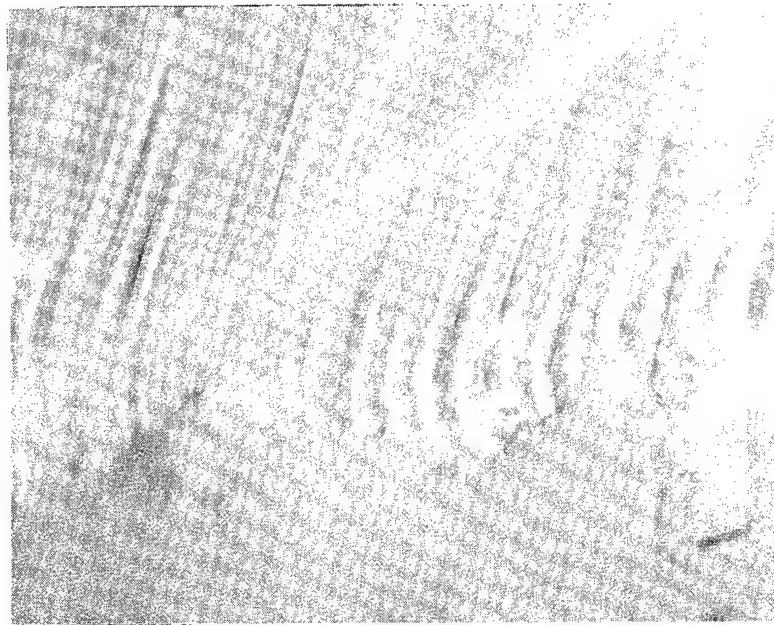
Visual examination revealed an opaque white fracture surface and an easily discernible fiber fabric weave. As shown in Figure 3.6-1 & 3.6-2, SEM examination revealed very few regions containing rivermarks, which would indicate the crack growth direction. In addition, there were numerous areas of matrix material cracking features that appear to be similar to hackles, which are usually indicative of a mode II shear loading than mode I tensile. The high strain rate test fracture surfaces Figure 3.6-3 & 3.6-4, exhibited a smaller region of fracture between the fabric plies. The "high" spots of the fabric weave were apparently the only areas that had fractured.

Figure 3.6-1. Optical Fractographs of a Rutapox/FG Fabric Interlaminar Mode I (Tensile) Fracture Surface, RT

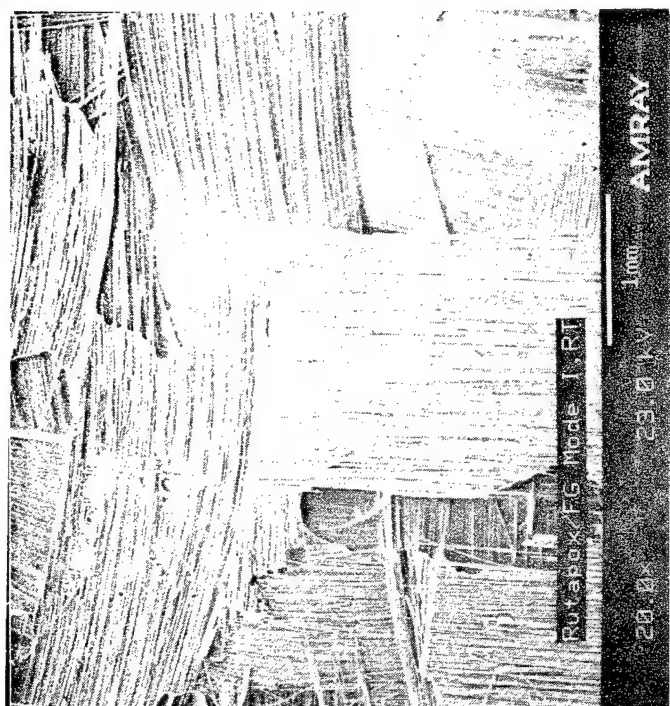
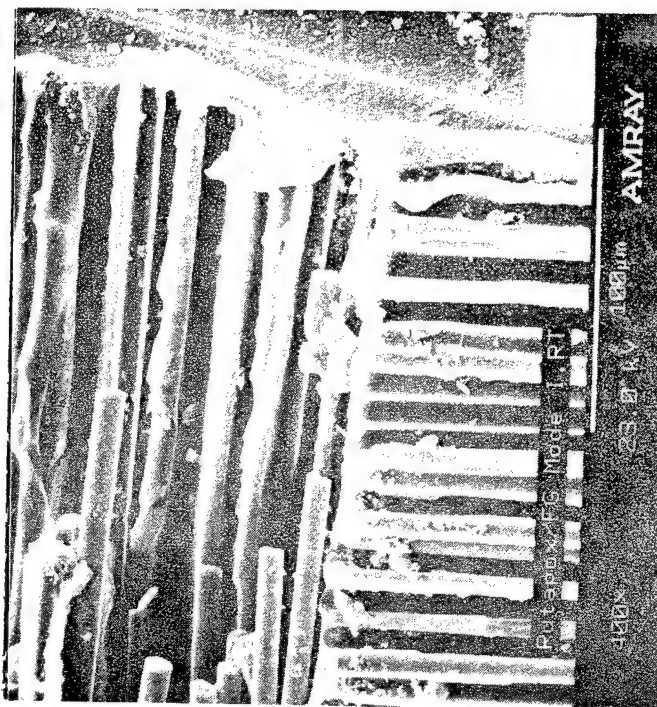
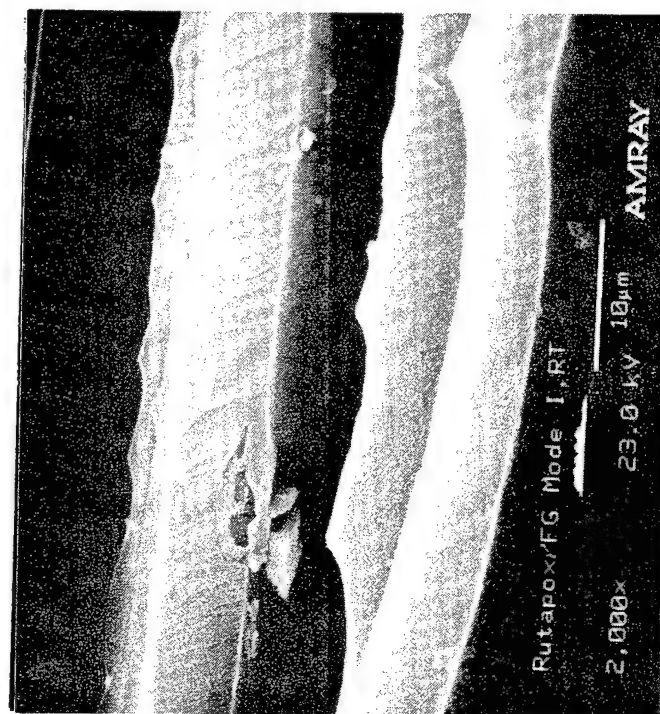
Figure 3.6-2. SEM Fractographs of a Rutapox/FG Fabric Interlaminar Mode I (Tensile) Fracture Surface, RT

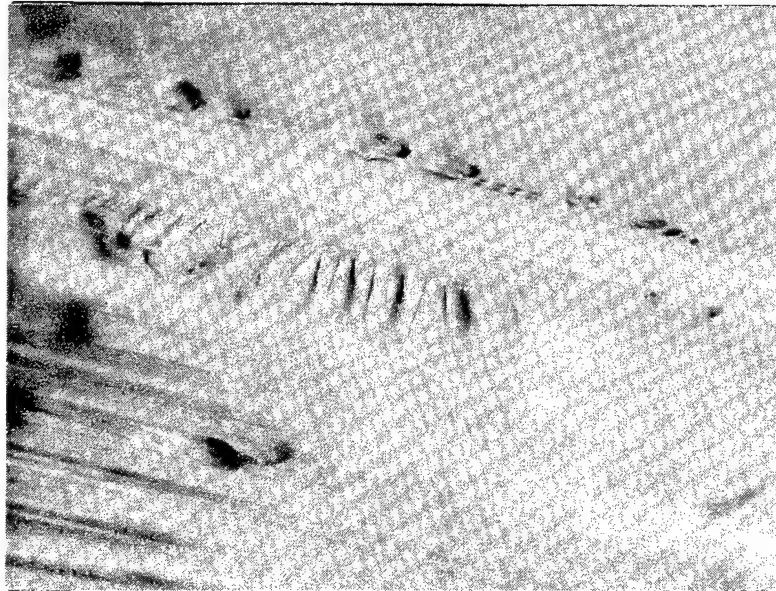
Figure 3.6-3. Optical Fractographs of a Rutapox/FG Fabric Interlaminar Mode I (Tensile) High-Rate Fracture Surface, RT

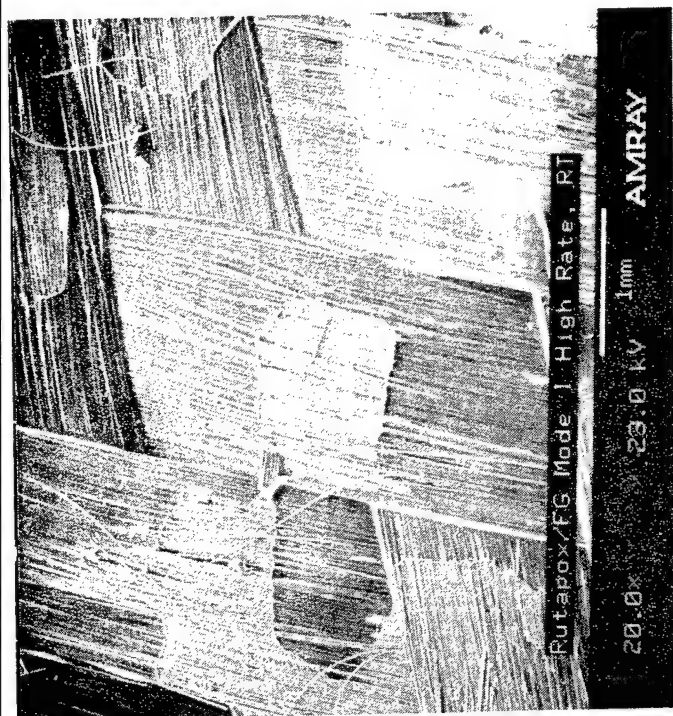
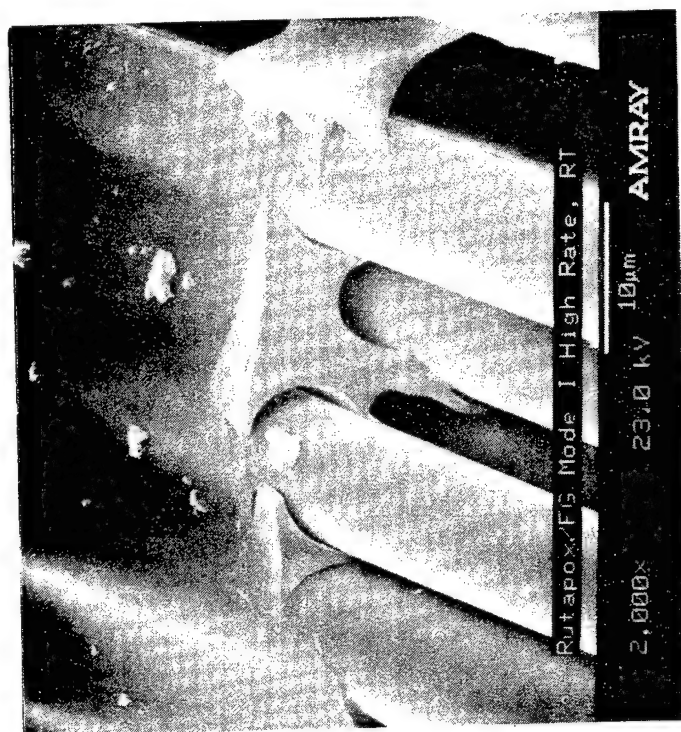
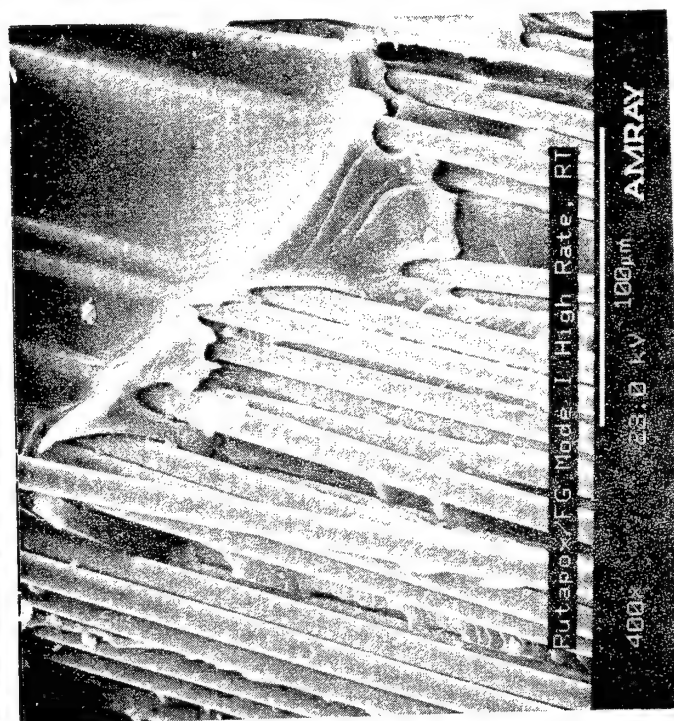
The fracture surfaces of both specimens exhibited similar features (Figure 3.6-4 & 3.6-5). The fabric tows parallel to the crack propagation orientation contained the hackles typical of a shear loading. Whereas the tows perpendicular to the crack direction exhibited ribbons of resin tearing from the fibers. The torn ends were generally bent towards the crack propagation direction.

Figure 3.6-4. SEM Fractographs of a Rutapox/FG Fabric Interlaminar Mode I (Tensile) High-Rate Fracture Surface, RT

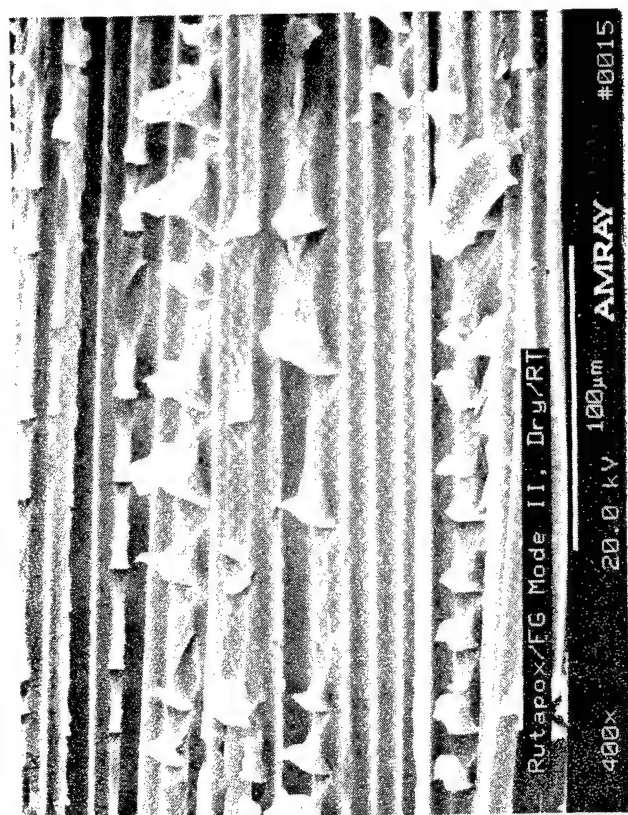
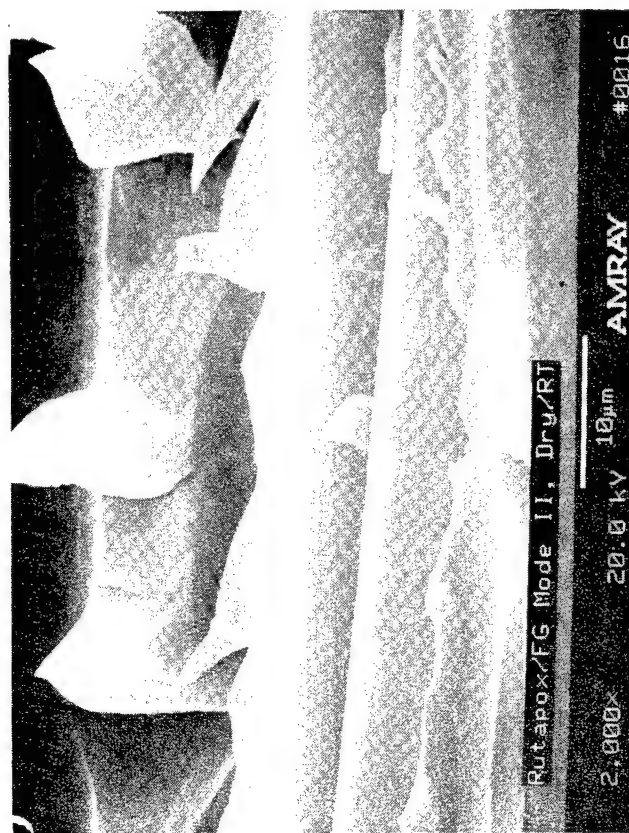
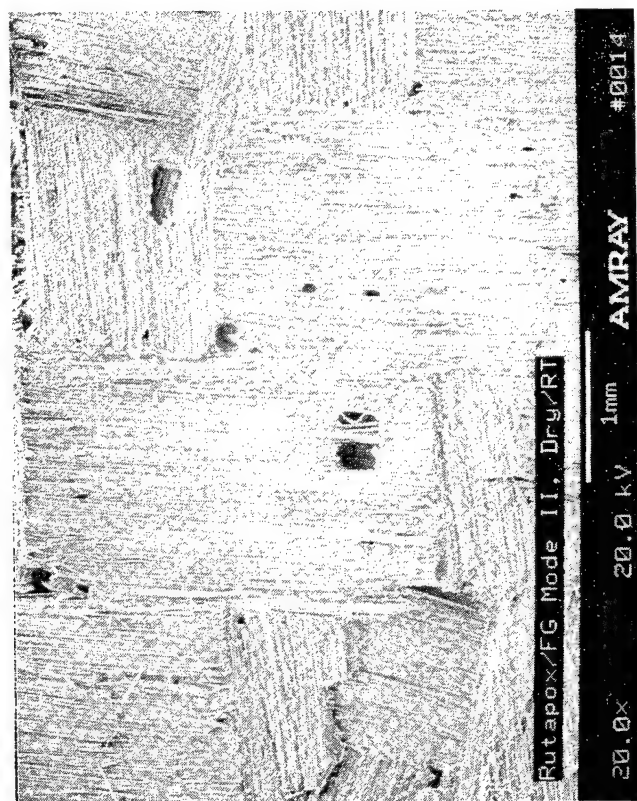
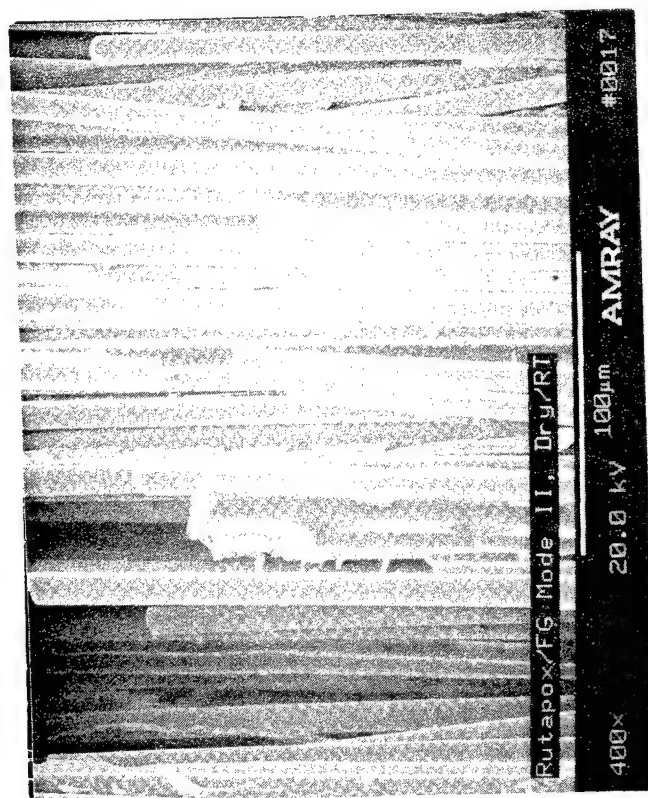
Figure 3.6-5. SEM Fractographs of a Rutapox/FG Fabric Interlaminar Mode II (Shear) Fracture Surface, RT
